UTE MOUNTAIN UTE TRIBE  
ENVIRONMENTAL PROGRAMS DEPARTMENT

**Exhibit C to December 16, 2011 Comments on DUSA RML Renewal**

**Re: Identification of Potential Tailings Cell Influence in Groundwater at White Mesa Mill**

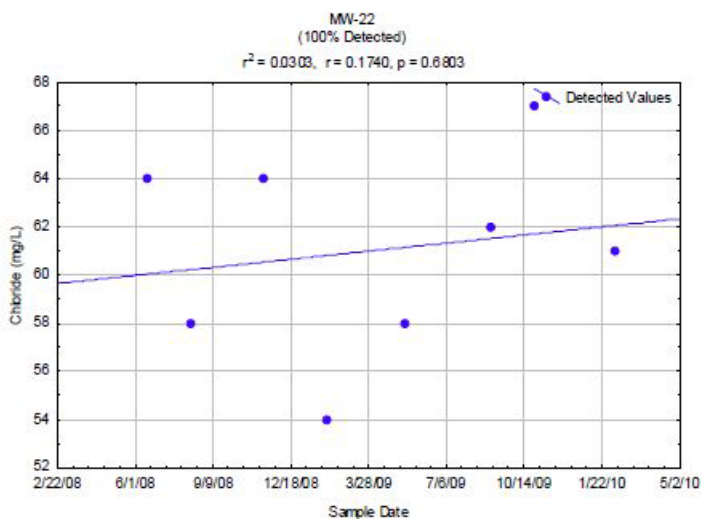
Background Report, 2007

DUSA has resolutely stated that chloride, followed by fluoride, is the best indicator of tailings cell leakage (“Revised Background Groundwater Quality Report: Existing Wells For Denison Mines (USA) Corp.’s White Mesa Mill Site, San Juan County, Utah, October 2007,” “Background Report”). Chloride has chemical properties that facilitate transport by water and it is often chosen as a tracer of groundwater flow. Chloride is present at elevated concentrations in MW-20 and MW-22 and the results exhibit a rising trend:

The Tribe demands that DRC designate MW-20 and MW-22 as Point of Compliance Wells and immediately require DUSA to implement the concurrent closure and other groundwater protection measures the Tribe has specified in, "Comments Regarding Denison Mines (USA) Corp. Radioactive Materials License Renewal DRC-045" along with any other groundwater remediation measures that are necessary to protect human health and the environment.

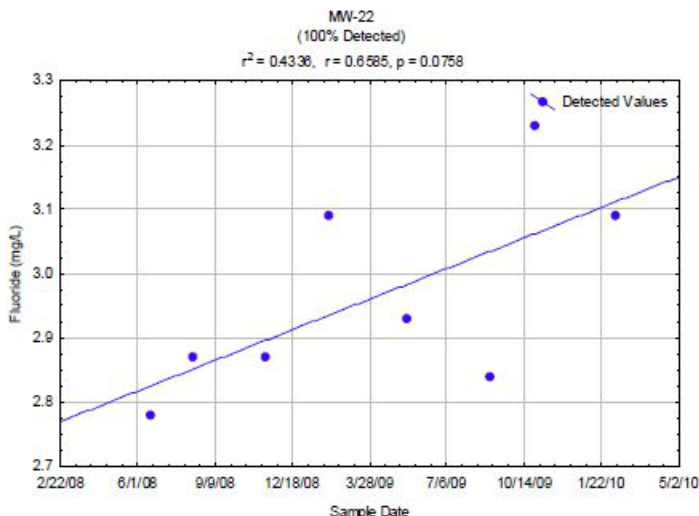
Background Report, 2007

Fluoride is cited by DUSA as the second-best indicator of tailings impact to groundwater at White Mesa, “Other than chloride, the constituent with most promise for indicating potential impacts from tailings solutions is fluoride,” Background Report page 9-3. Fluoride is also present at elevated levels on a rising trend in MW-20 and MW-22:
